On Flute Headcorks:

We've seen a lot of brand new flutes that have head cork issues.

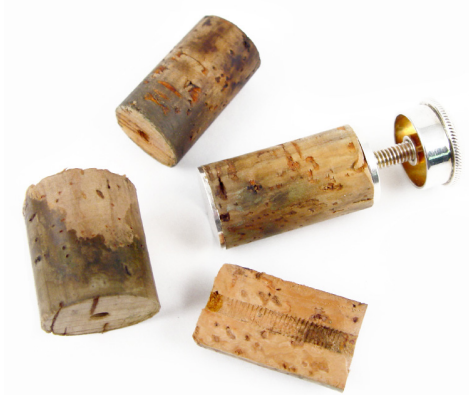
Of major note is a trend towards some very poor quality cork being used. We see that a lot of these cheap corks absorb water and begin to rot. This certainly creates performance problems. I have an additional concern that it may create possibly health issues from the growth of mold or bacteria.

At issue is that if the cork can absorb water, it is also leaking air. If the moisture from the breath gets past the cork plate, so does the air. If the air is getting up past the plate, it is leaking. Even if the air doesn't escape the North end of the headjoint, it is leaking into the cork. To perform its best, the headjoint needs to seal at the cork plate, not at some undetermined place further up the head.

You can easily remove and reinstall the cork with our flute head joint cork tool set (product #227023). The rotted corks can be squeezed between the fingers at the Southern end. Replace any rotted cork, or any cork that shows water stains North of the cork plate. If you've had customers complaining of intermittent performance problems (pitch, response and so forth) with their flute, consider that the flute will begin to perform better once it is "warmed up". Once the cork fills up with condensation from the breath, it now seals better and will perform differently.
